REPORT OF FINDINGS

JERI GILL-MCKENZIE RESIDENCE

NOVEMBER 28, 2020

Property Address:
3424 Mount Washington Road
Ardmore, OK 73401

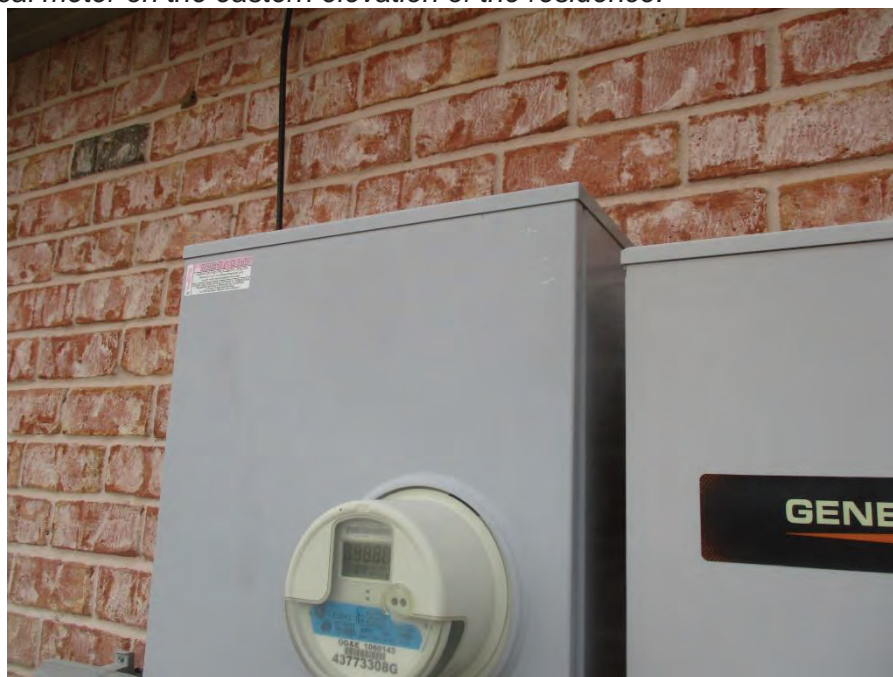
Photograph 5

View of an electrical meter on the eastern elevation of the residence.

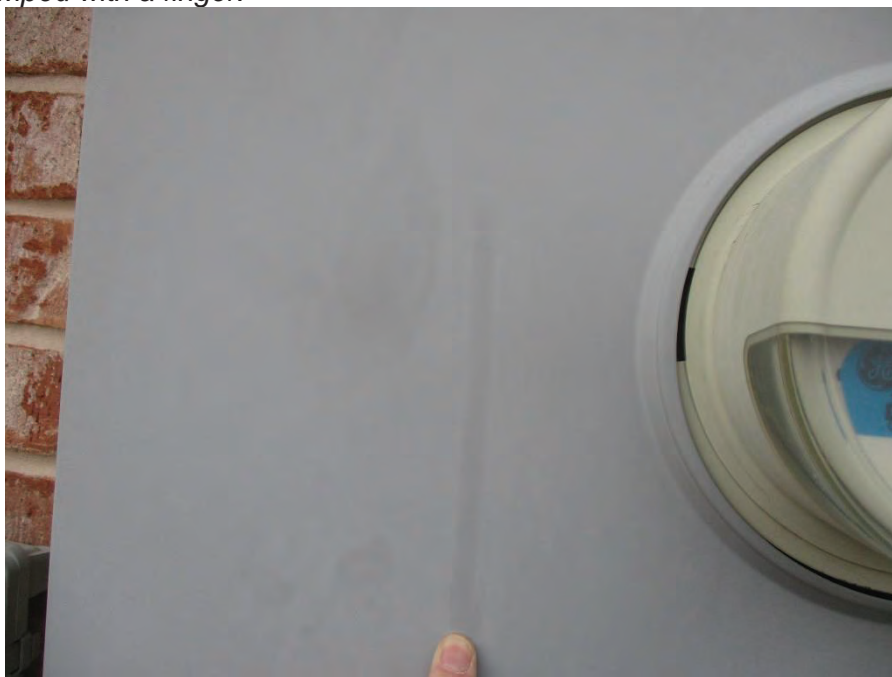
Photograph 6

View of the electrical meter shown in Photograph 5. Note the absence of spatter marks and that markings were left when swiped with a finger.

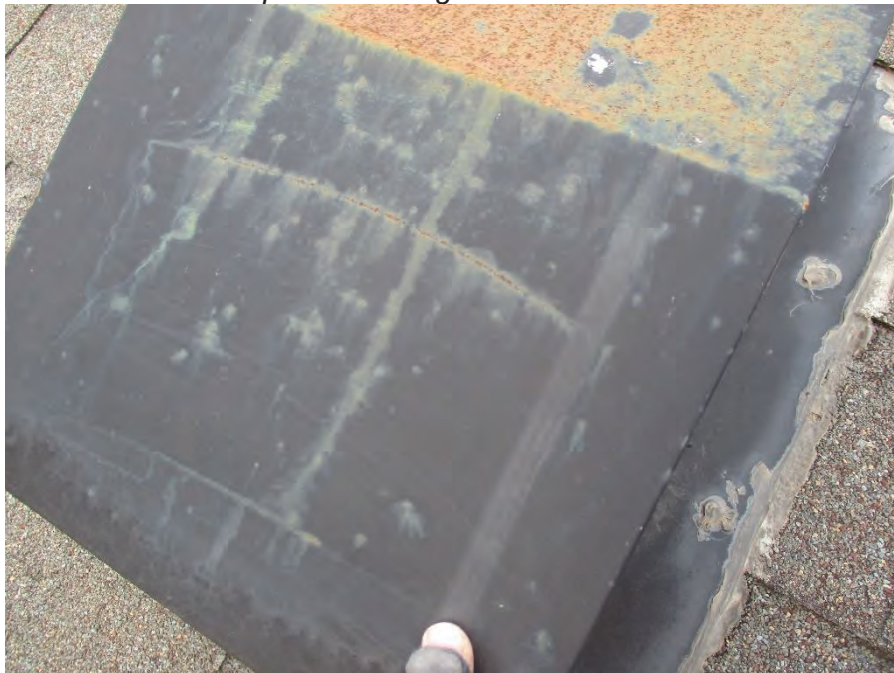
Photograph 7

View of a metal vent on a south-facing roof slope of the residence. Note the absence of spatter marks and that markings were left when swiped with a finger.

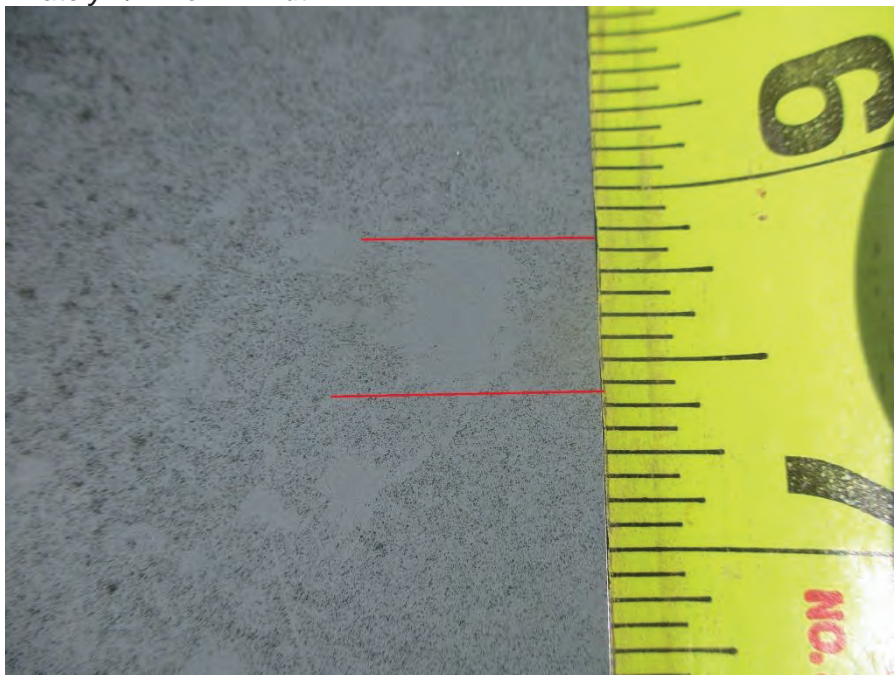
Photograph 8

Inspection of the peripheral building elements on the roof and around the residence and inspection of the metal roof panels on the detached storage building revealed isolated markings consistent with hail spatter marks that measured up to approximately 1/2-inch in width (Attachment A, Photographs 5 through 8). Evidence of indentations consistent with impact from hail were observed in some, but not all, of the gutter downspouts and soft metal appurtenances on the roof (Attachment A, Photographs 9 through 13). These indentations typically measured up to approximately 3/8-inch in width. Ice ball impact testing studies have shown that the strongest correlation between hailstone diameter and dent size is the smallest measured width of the inner dent, which is defined by the well-defined steep slopes about the center of the impact. Furthermore, the relationship between hailstone diameter and dent size is specific to appurtenance types, profiles, and thicknesses. In the case of the indentations in the soft metal appurtenances, ice ball impact testing suggests that the inner dent width-to-hailstone diameter is approximately 0.5. As such, the sizes of the aforementioned indentations in the soft metal appurtenances (3/8-inch) indicated that the property had been exposed to hailstones that were up to approximately 3/4-inches in diameter.

View of a spatter mark on a metal roof panel of the detached storage building. Note that the spatter mark measured approximately 1/2-inch in width.

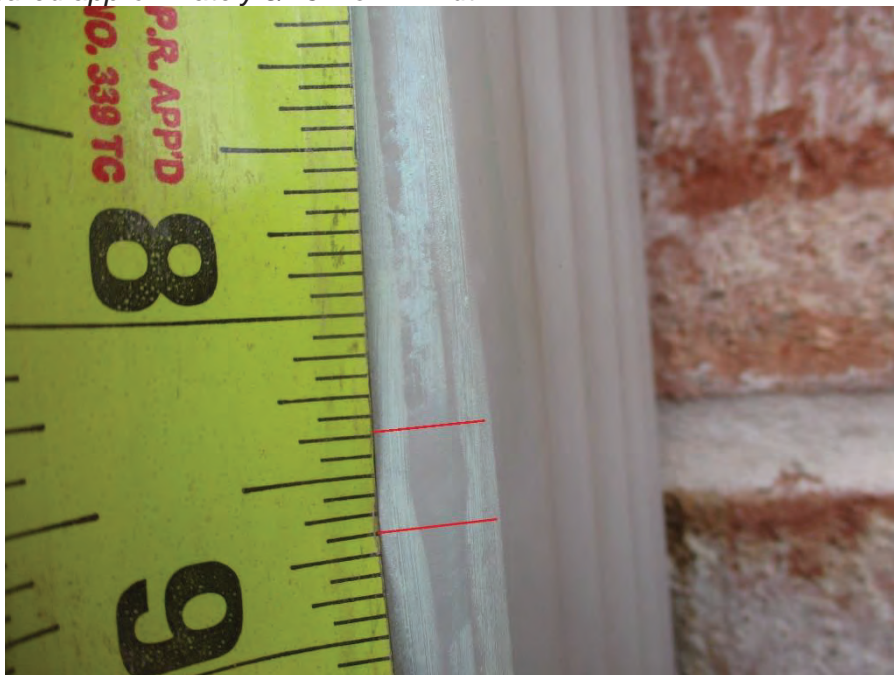
Photograph 9

View of an indentation in a gutter downspout on the western elevation of the residence. Note that the indentation measured approximately 5/16-inch in width.

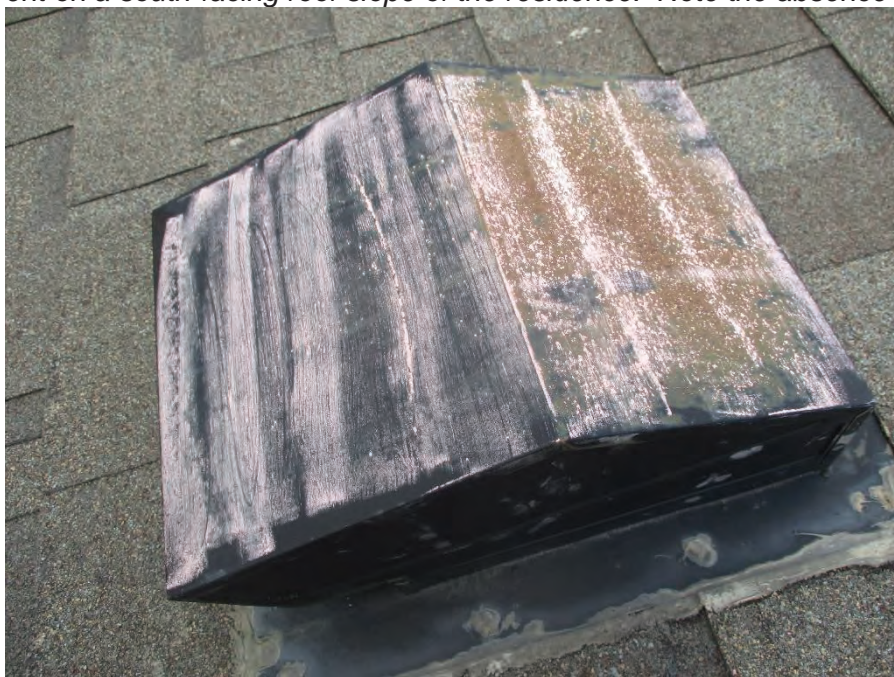
Photograph 10

View of a metal vent on a south-facing roof slope of the residence. Note the absence of indentations.

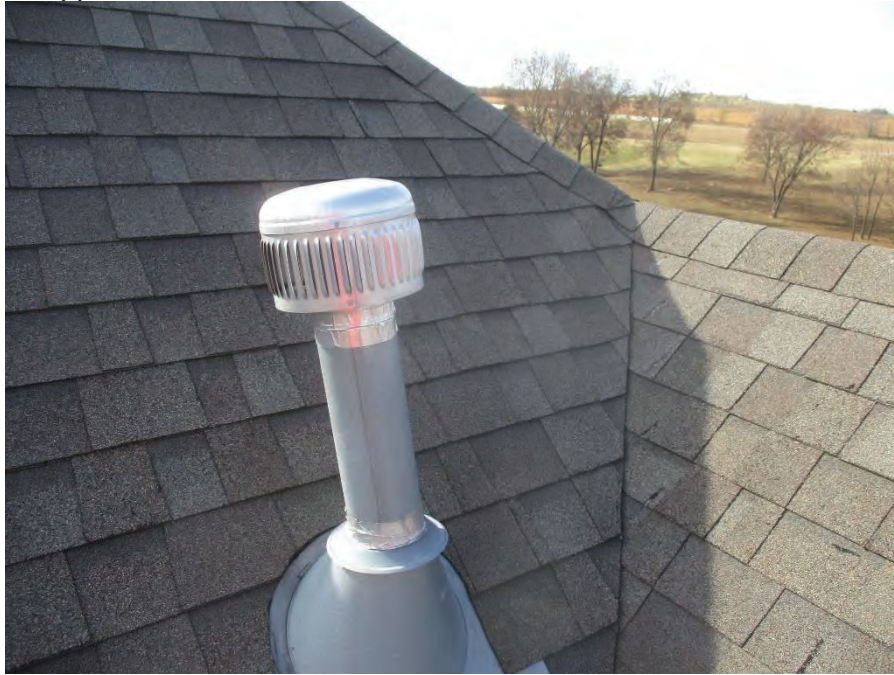
Photograph 11

View of a soft metal appurtenance on the roof of the residence.

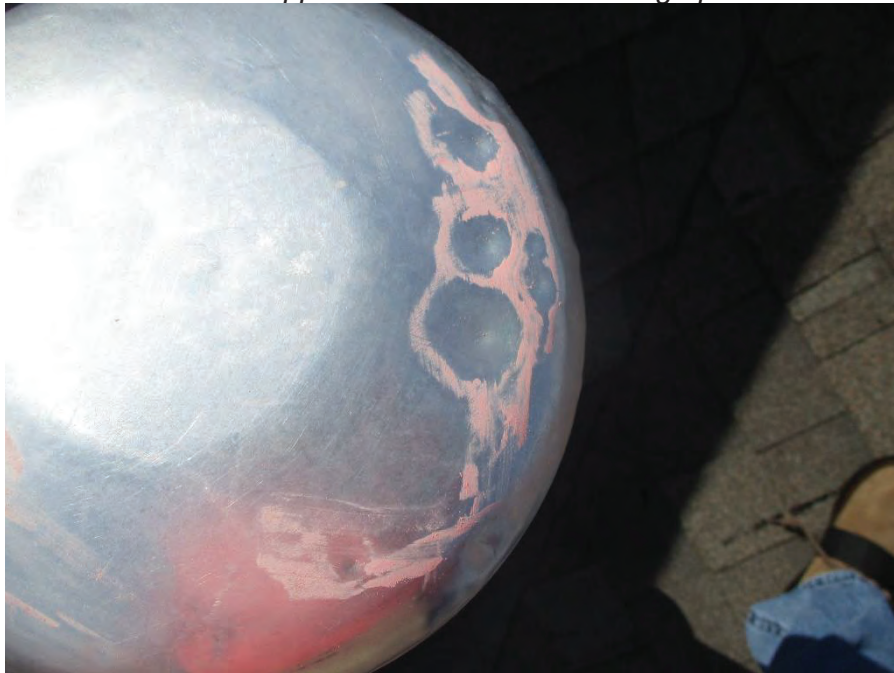
Photograph 12

View of indentations in the soft metal appurtenance shown in Photograph 11.

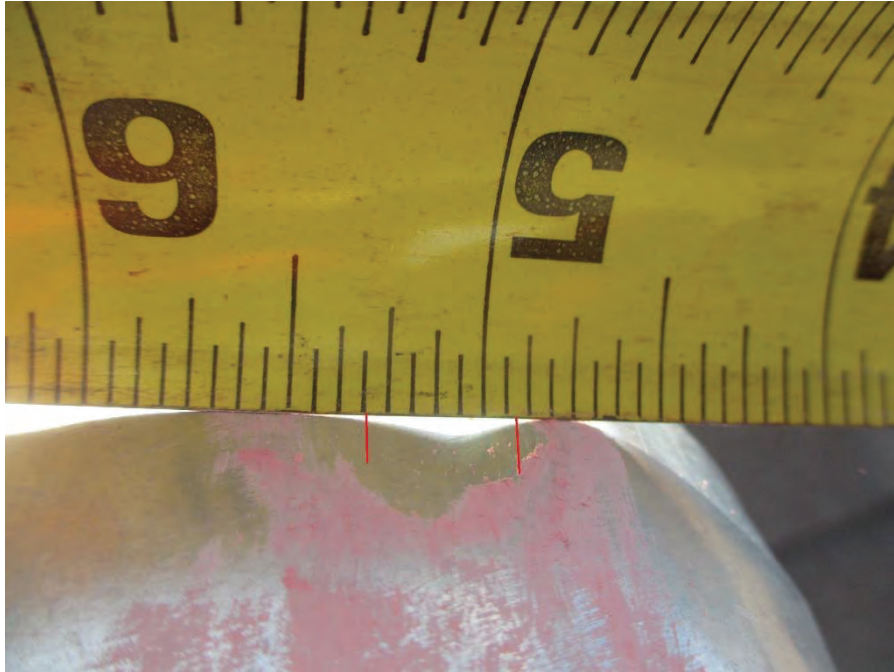
Photograph 13

View of the width of one of the indentations shown in Photograph 12. Note that the indentation measured approximately 3/8-inch in width.

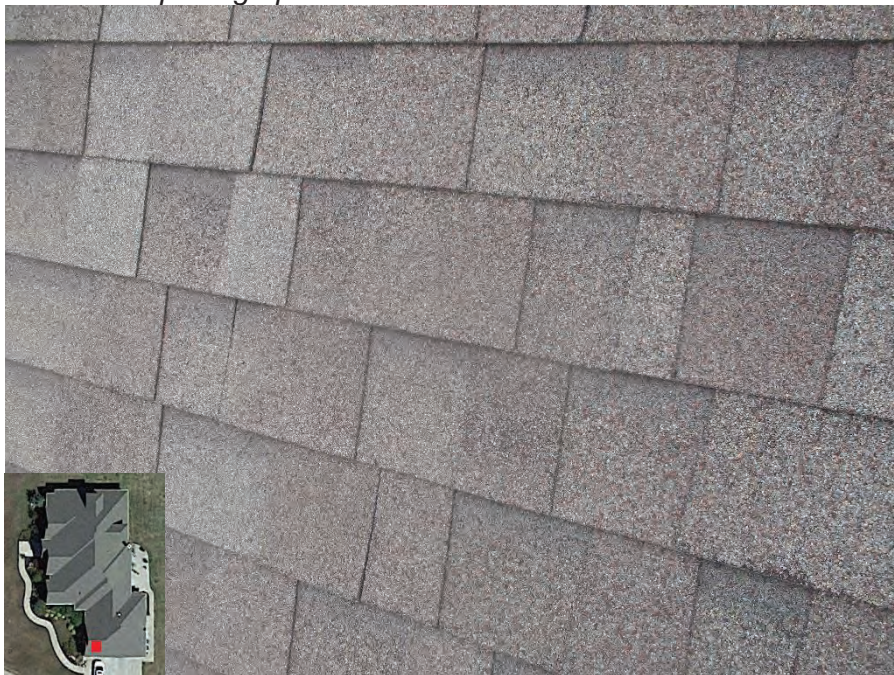
Photograph 20

Hail impact-related damage to asphalt composition shingle roofing is typically evidenced by a random-distribution of roughly circular blemishes. It has been DEC's experience that these blemishes are generally no smaller than approximately 3/4-inch in diameter, which are characterized by missing granules, granules forced into the shingle mat, and a reduced cross-section (bruising), dimpling, and/or fracturing of the shingle mat. Bruising of the shingle mat produces a weak spot that feels softer and more pliable than the remainder of the shingle. Hail-related damage is typically most severe along ridges, rakes, and eaves where substrate support for the shingles is discontinuous. Due to the directional nature of hailstorms, it is typical for hail damage to roofing to concentrate on the slope of the roof that is most perpendicular to the direction of the storm as this will result in greater energy transfer from the hailstone. While distribution of such damage is random, the frequency of damage is typically consistent across any one affected slope of a roof with the exception of areas that are shielded from hailstone impacts by overhanging features such as upper stories, roof overhangs, or trees. Hailstone impacts to the surface of the roof most parallel to the trajectory of the hailstone commonly glance off the surface of the roof, imparting less damage at impact. DEC's visual and tactile inspection of the asphalt composition shingle roofing system of the residence found no evidence of damage consistent with impact from hail as described herein. (Attachment A, Photographs 14 through 29)

View of the representative condition of the roofing system at the approximate location indicated by the red square in the inset aerial photograph.

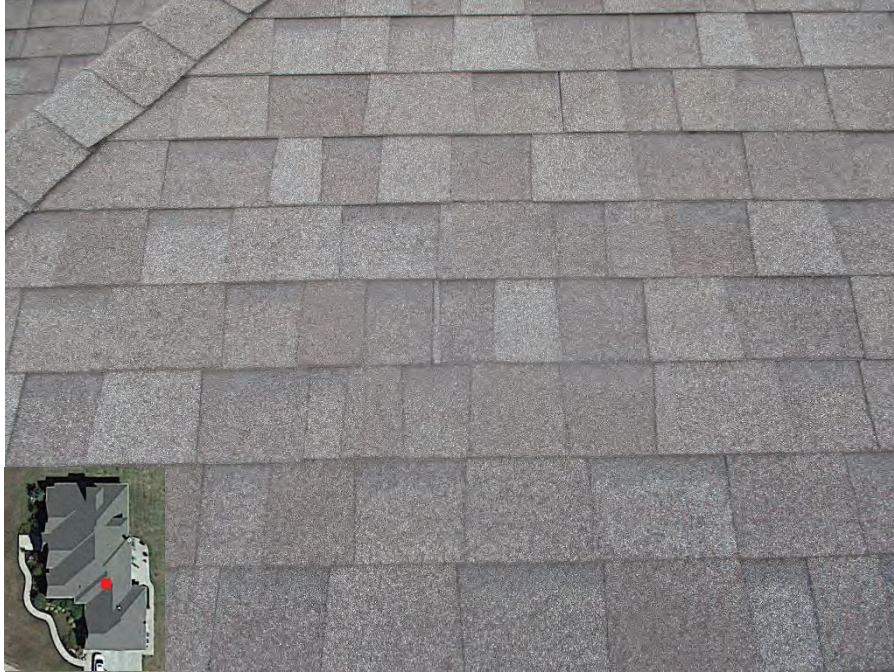
Photograph 21

View of the representative condition of the roofing system at the approximate location indicated by the red square in the inset aerial photograph.

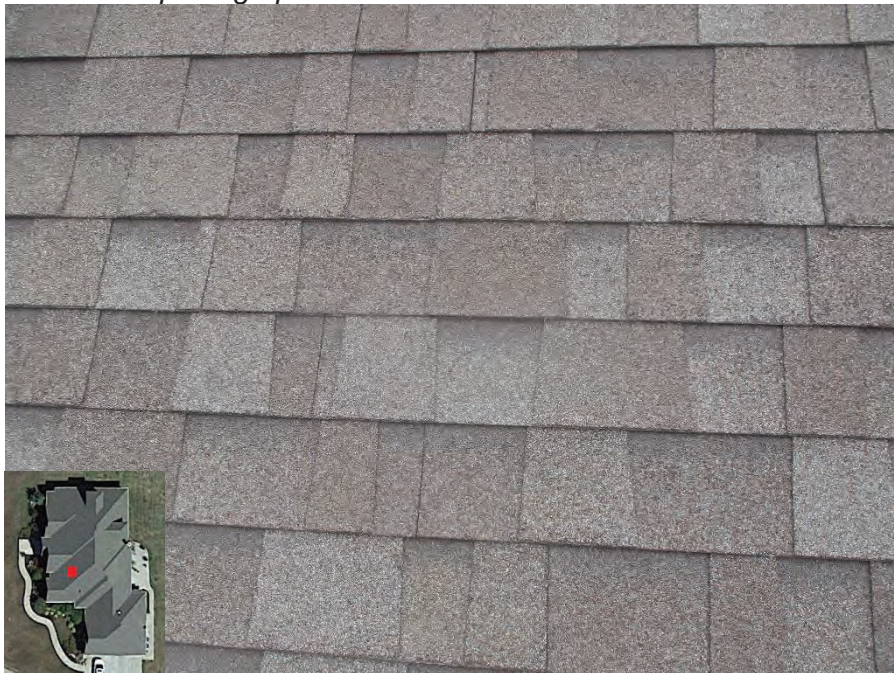
Photograph 22

View of the representative condition of the roofing system at the approximate location indicated by the red square in the inset aerial photograph.

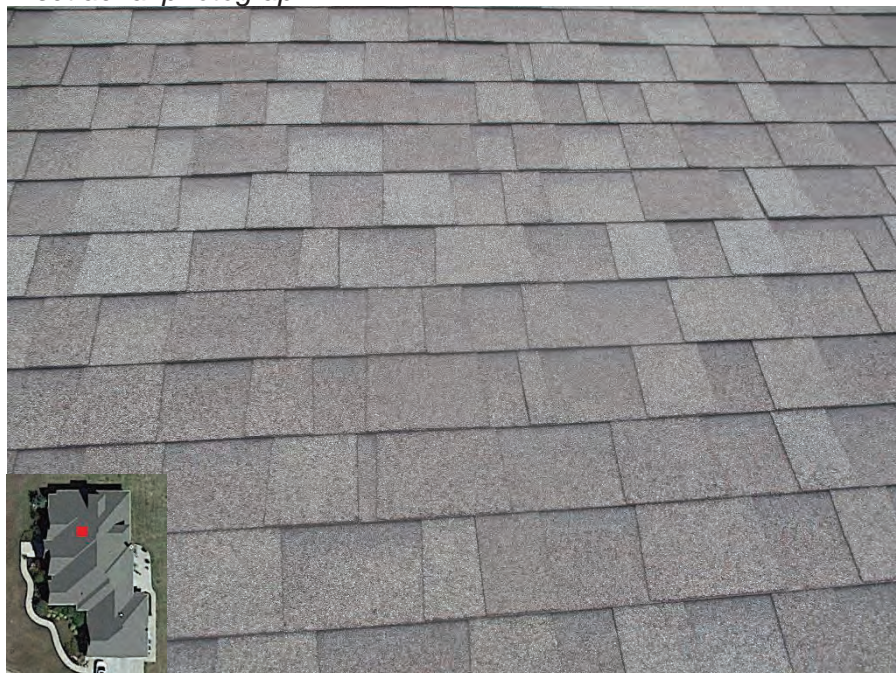
Photograph 23

View of the representative condition of the roofing system at the approximate location indicated by the red square in the inset aerial photograph.

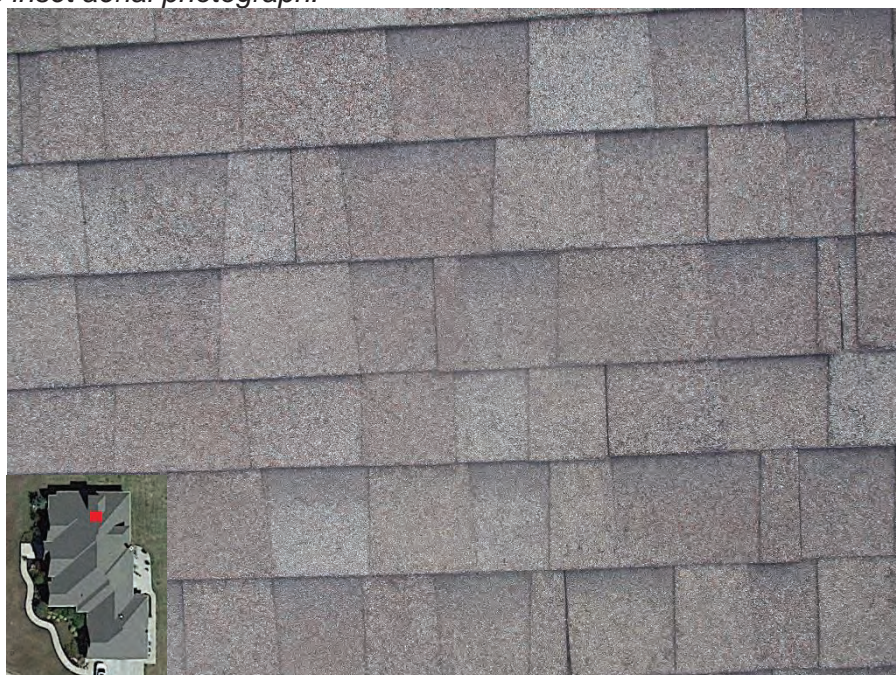
Photograph 24

View of the representative condition of the roofing system at the approximate location indicated by the red square in the inset aerial photograph.

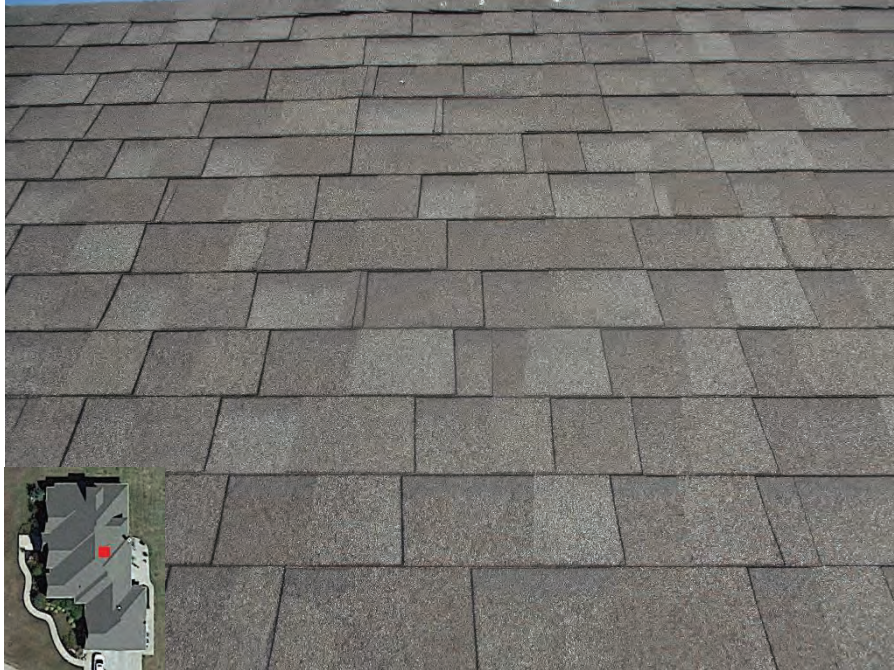
Photograph 25

View of the representative condition of the roofing system at the approximate location indicated by the red square in the inset aerial photograph.

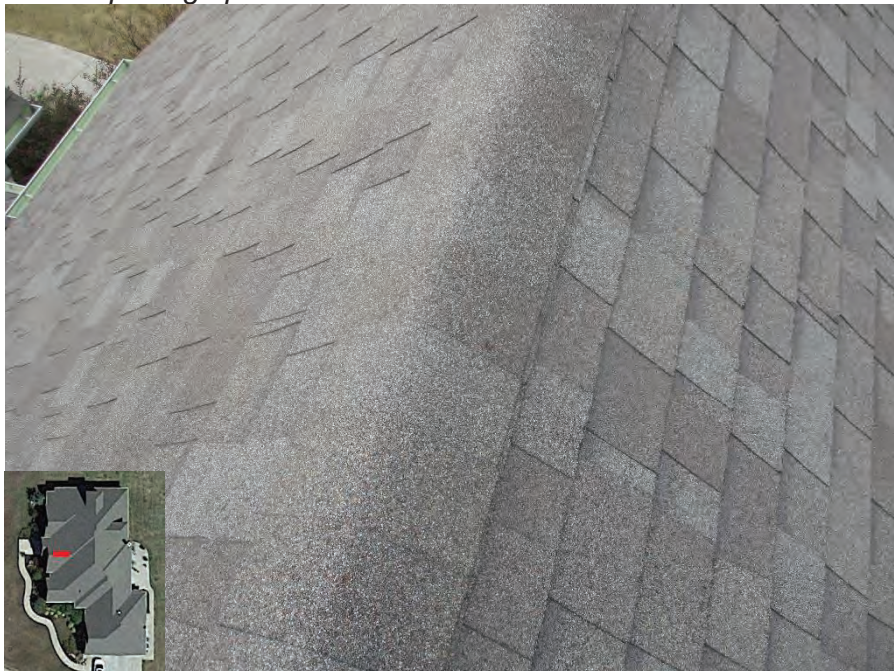
Photograph 26

View of the representative condition of the ridge shingles at the approximate location indicated by the red square in the inset aerial photograph.

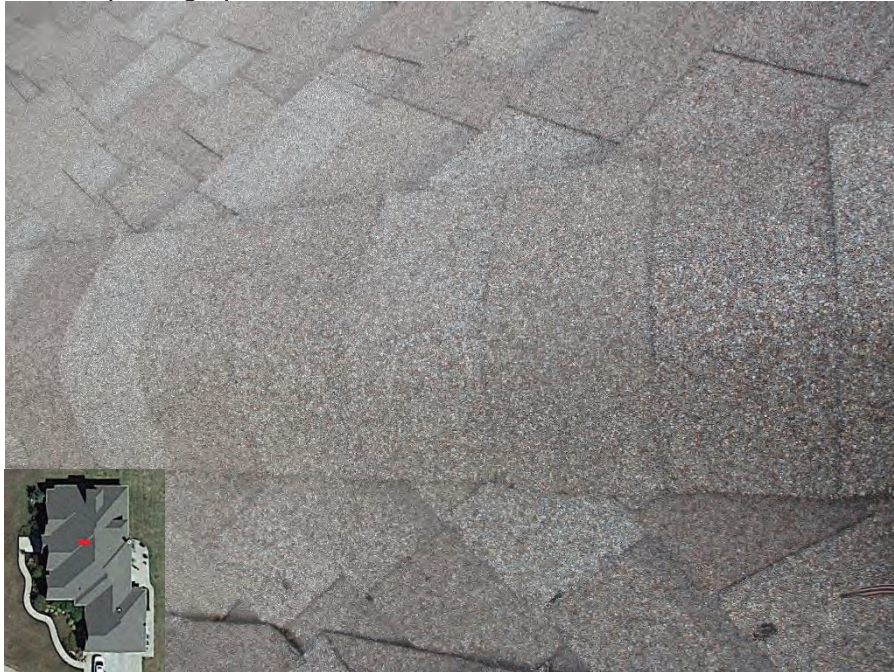
Photograph 27

View of the representative condition of the hip shingles at the approximate location indicated by the red square in the inset aerial photograph.

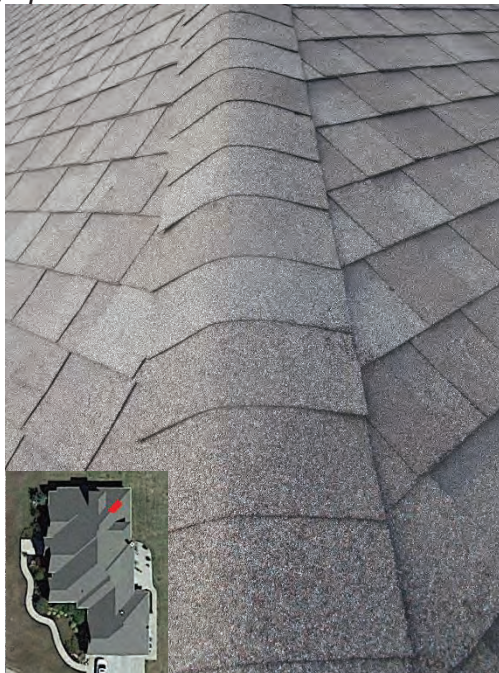
Photograph 28

View of the representative condition of the hip shingles at the approximate location indicated by the red square in the inset aerial photograph.

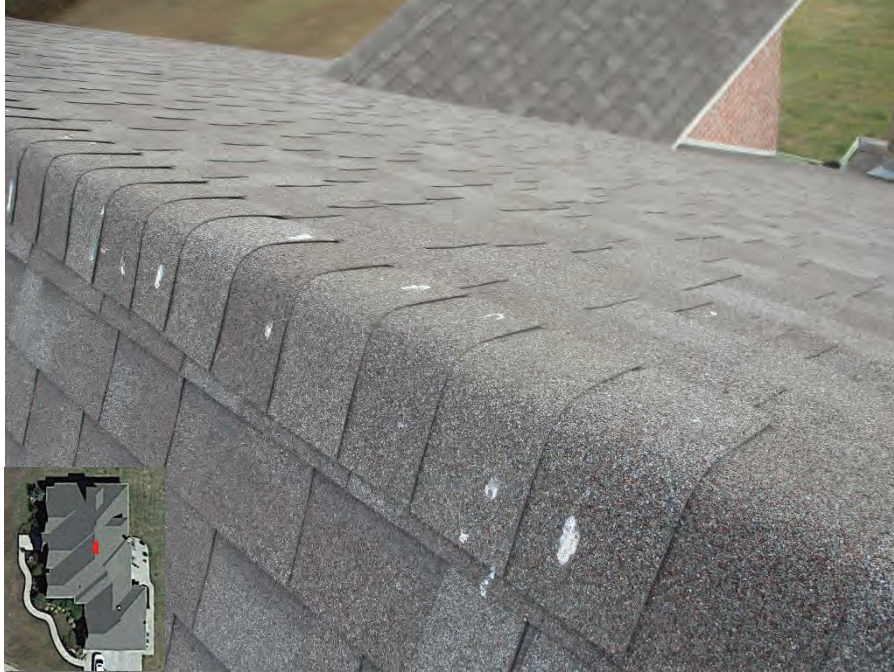
Photograph 29

View of the representative condition of the ridge shingles at the approximate location indicated by the red square in the inset aerial photograph.

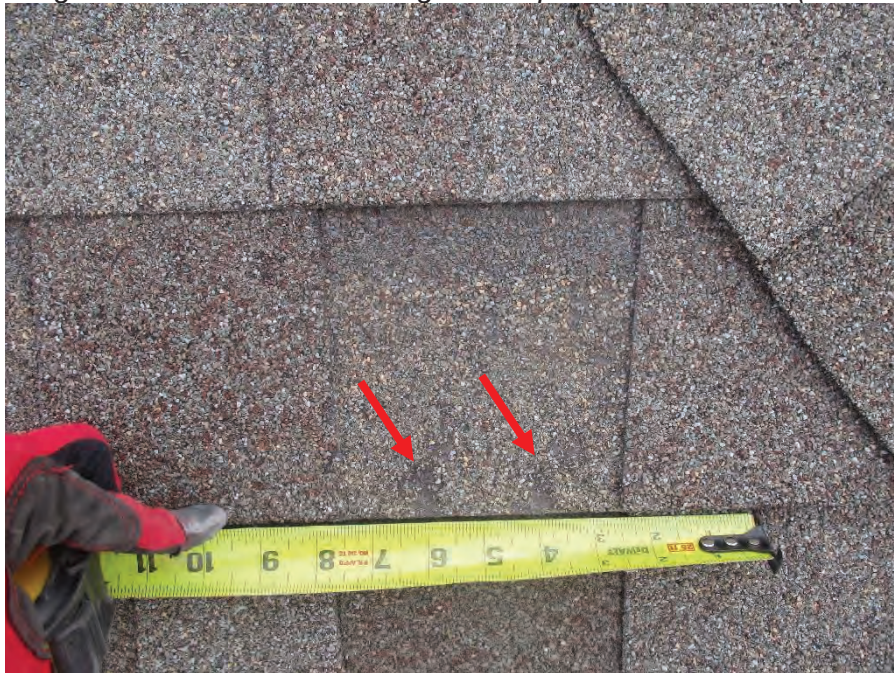
Photograph 30

During inspection of the roof of the residence, areas of granule loss were observed that are commonly mistaken for hail impact-related damage. Inspection of these blemishes revealed characteristics that were not consistent with damage by impact from hail. Although some of the blemishes were roughly circular in shape, others were linear and/or occurred along the leading edges of the shingles. Other areas of granule loss exhibited varying shapes and sizes not consistent with impact from hail. As previously discussed, it has been DEC's opinion that blemishes caused by hail impact are typically no smaller than approximately 3/4-inch in diameter. Some of the blemishes observed by DEC measured approximately 1/4-inch in width.

Furthermore, there was an absence of granules driven into the shingle mat and the blemishes did not exhibit a perceptible softness under pressure of finger. Thus, DEC concluded that the areas of granule loss were consistent with weathering of the shingles. (Attachment A, Photographs 30 through 37)

View of two areas of granule loss on a west-facing roof slope of the residence (indicated by the arrows).

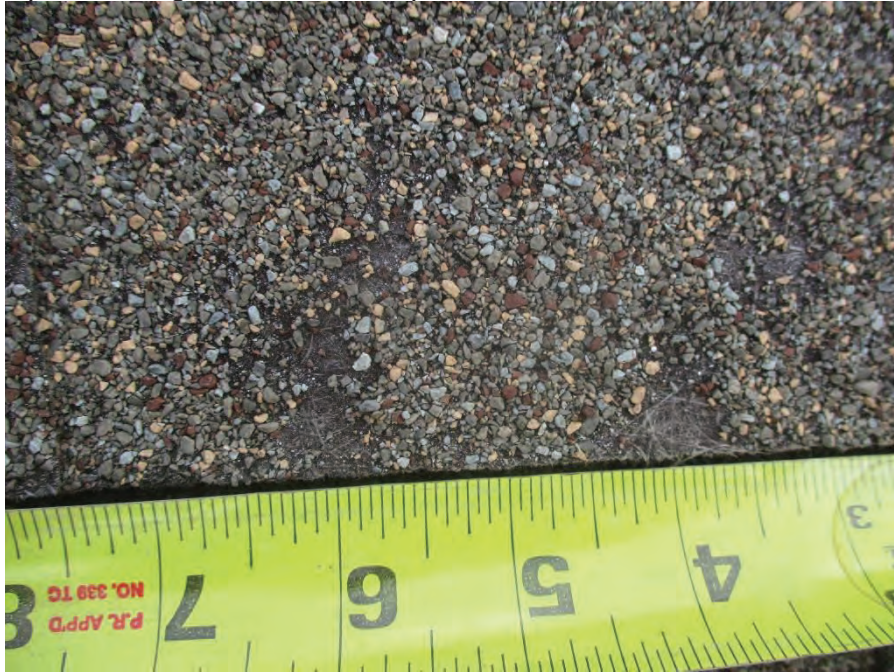
Photograph 31

Close-up view of the areas of granule loss indicated by the arrows in Photograph 30. Note the light gray coloration of the exposed shingle mat and the exposed mat fibers.

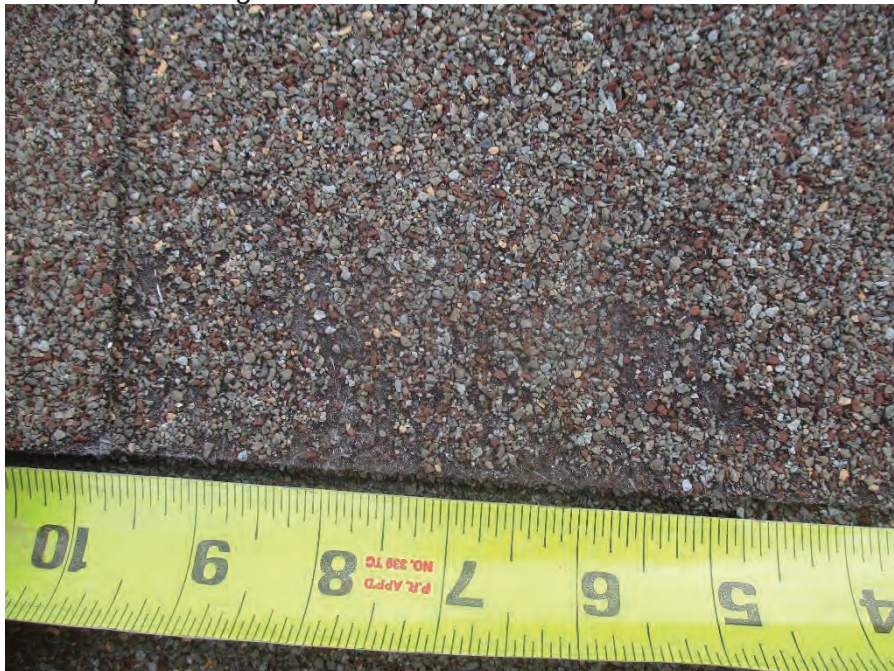
Photograph 32

View of areas of granule loss on a shingle on a west-facing roof slope of the residence. Note the light gray coloration of the exposed shingle mat.

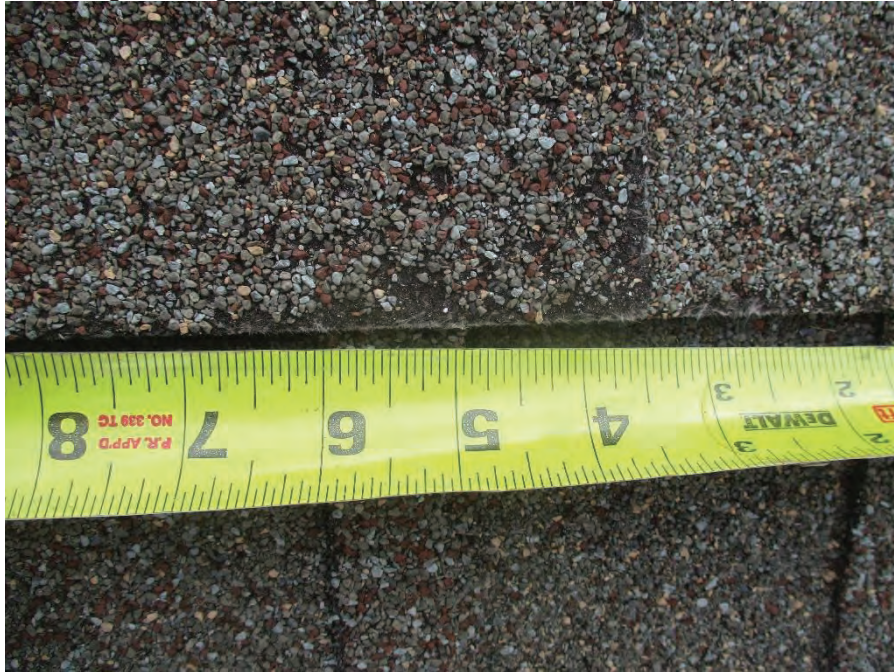
Photograph 33

View of granule loss along the edge of a shingle on a west-facing roof slope.

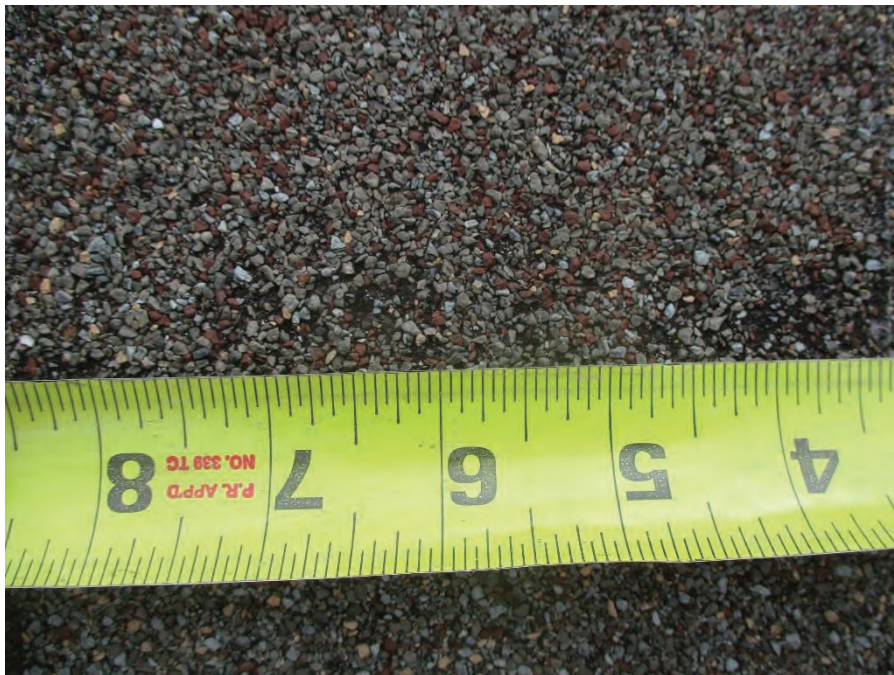
Photograph 34

View of areas of granule loss on a shingle on a west-facing roof slope. Note the relatively small size of the areas of granule loss.

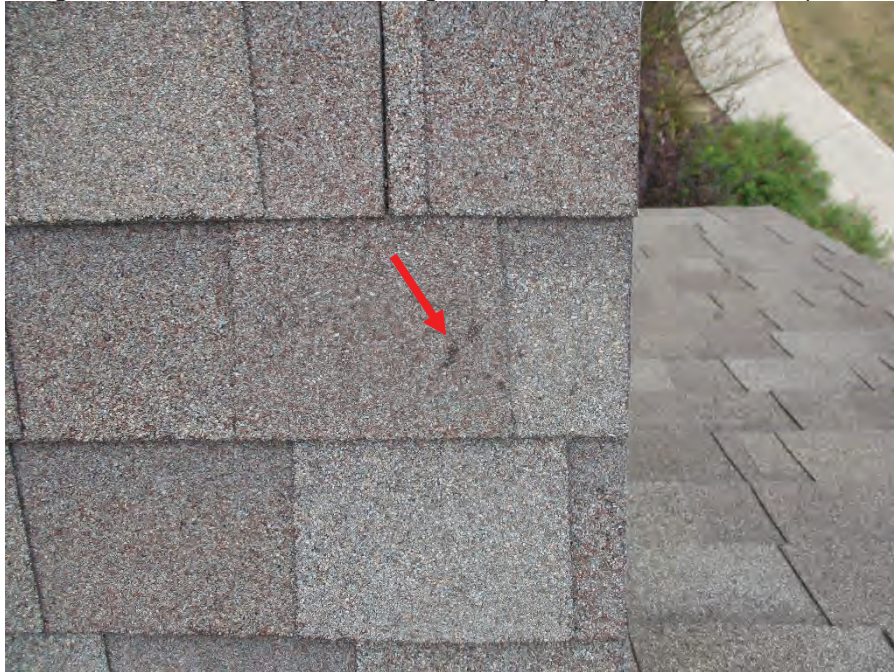
Photograph 35

View of two areas of granule loss on a north-facing roof slope of the residence (indicated by the arrow).

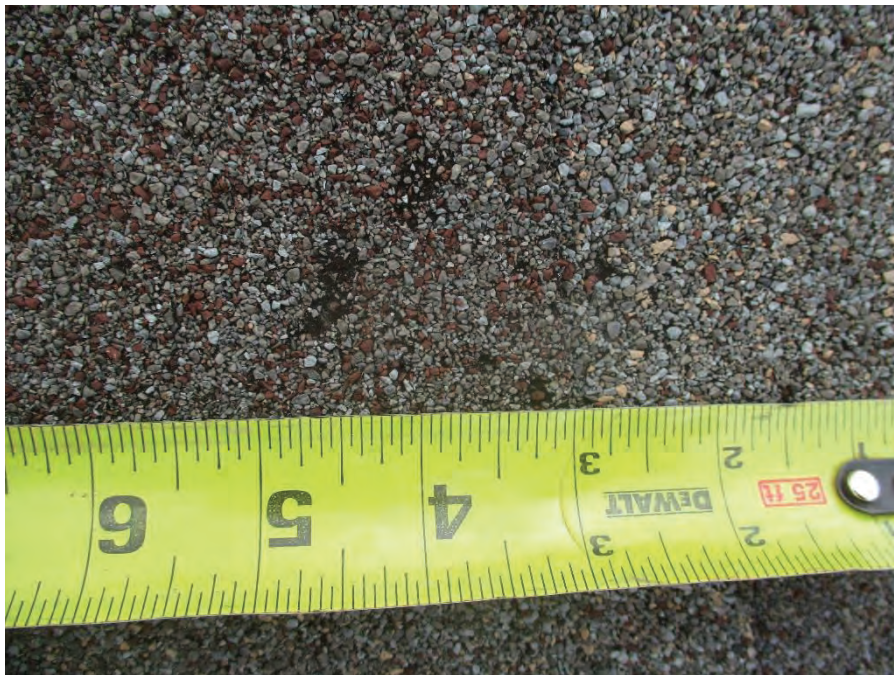
Photograph 36

Close-up view of the areas of granule loss indicated by the arrow in Photograph 35. Note the relatively small size of the blemishes.

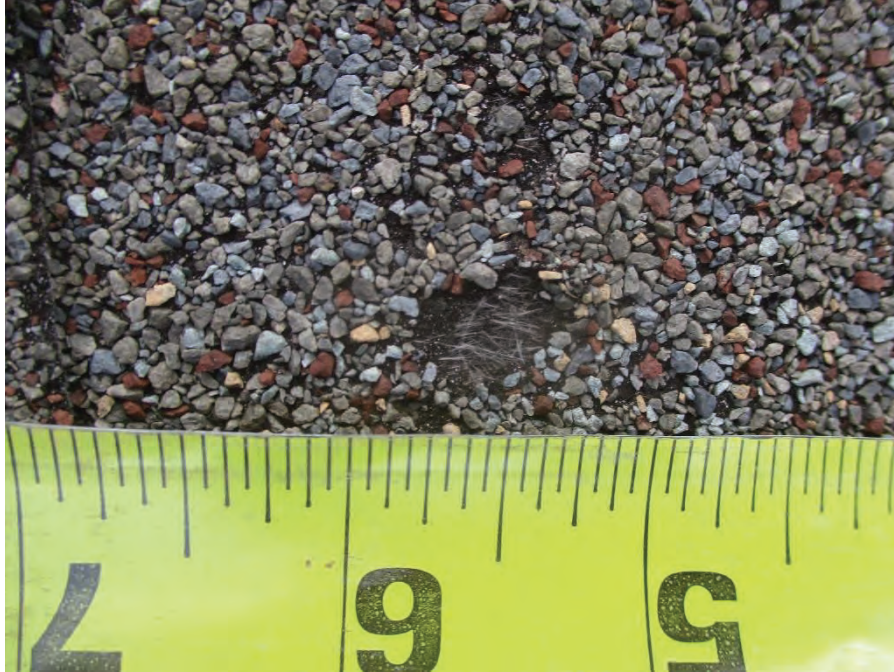
Photograph 37

View of an area of granule loss on a west-facing roof slope. Note the relatively small size of the blemish, the absence of granules driven into the shingle mat, and the exposed fibers of the mat.

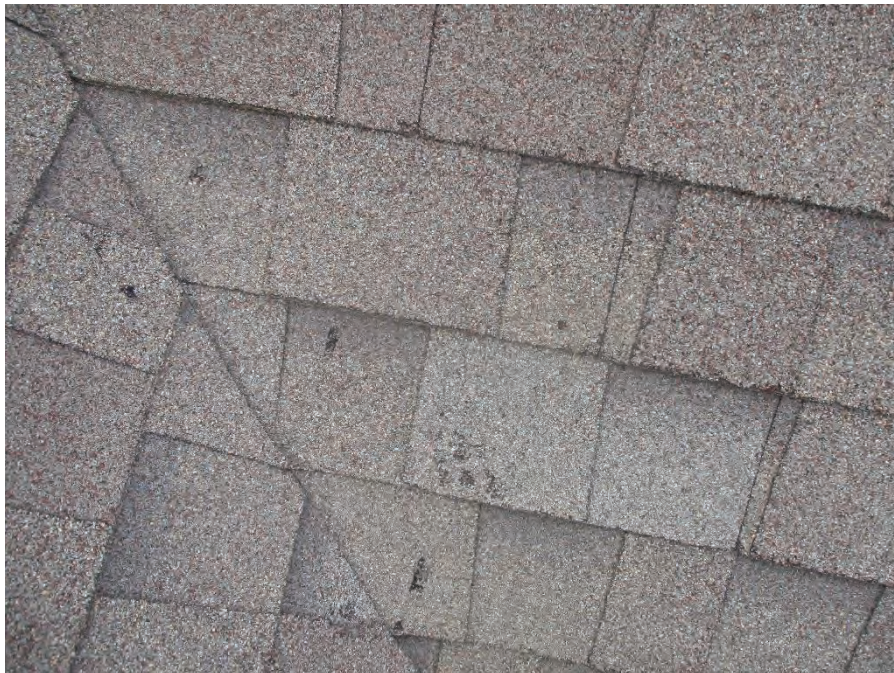
Photograph 38

Other conditions were observed on the roof of the residence that were consistent with mechanical shingle damage and/or potential material deficiencies. Mechanical shingle damage refers to a wide variety of damages, intentional or unintentional, resulting from sources other than weather or natural material deterioration. A few examples of commonly seen mechanical shingle damage include damages caused during installation and/or maintenance such as bends and/or tears at shingle edges and/or corners caused by the dragging of feet, granule loss caused by foot traffic, and linear scratches and/or cuts caused by tools. Granule loss and/or abrasions caused by foot traffic commonly occur along roof valleys that are utilized for roof access. Various areas of damage consistent with unintentional mechanical damage were observed by DEC. (Attachment A, Photograph 38)

View of abrasions/areas of granule loss adjacent to a roof valley on a west-facing roof slope of the residence.

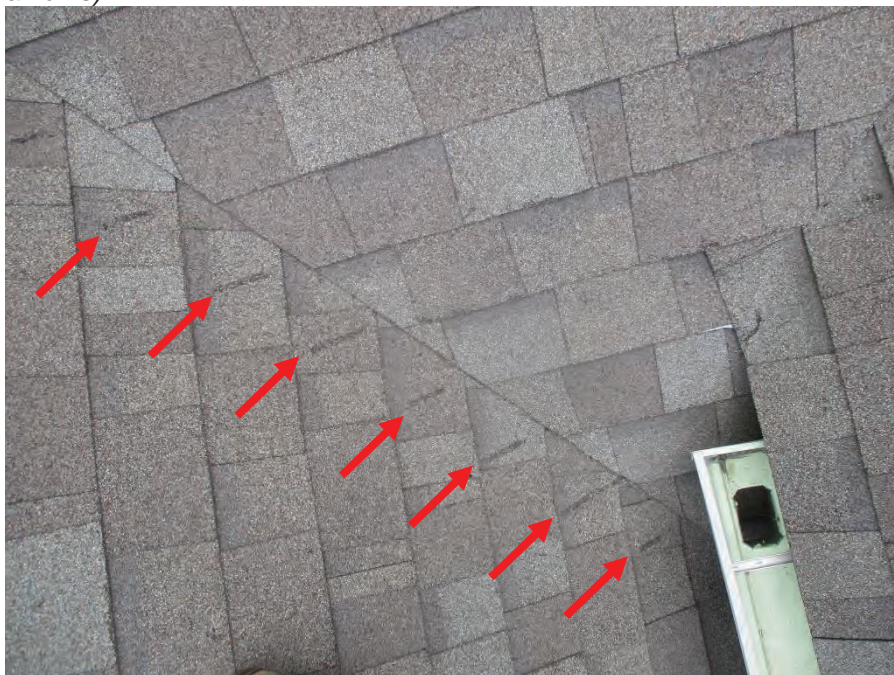
Photograph 39

Other areas of damage/granule loss were observed that exhibited a frequency and/or pattern not consistent with having resulted from impact from hail. On a west-facing roof slope, linear abrasions were observed at the end of each shingle course directly adjacent to a roof valley. At several locations on south-facing roof slopes, widespread and extensive granule loss was observed to occur on groupings/areas of shingles. However, groupings/areas of shingles directly adjacent and on the same roof slope did not exhibit a similar extent of granule loss. This pattern of damage suggested potential material deficiencies related to the shingles (i.e. a defective bundle of shingles). At the areas of granule loss, the exposed shingle mat exhibited a light gray coloration and the mat fibers were visible. These characteristics were consistent with long-term weathering of the exposed asphalt of the shingle and indicated that the granule loss was not a recent occurrence. (Attachment A, Photographs 39 through 44)

View of a pattern of linear abrasions adjacent to a roof valley on a west-facing roof slope of the residence (indicated by the arrows).

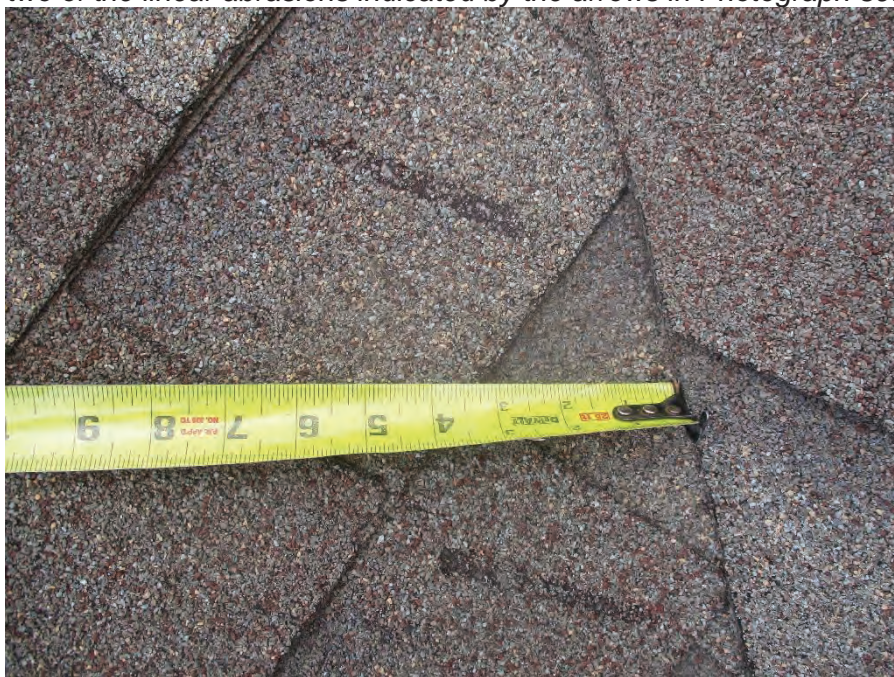
Photograph 40

Close-up view of two of the linear abrasions indicated by the arrows in Photograph 39.

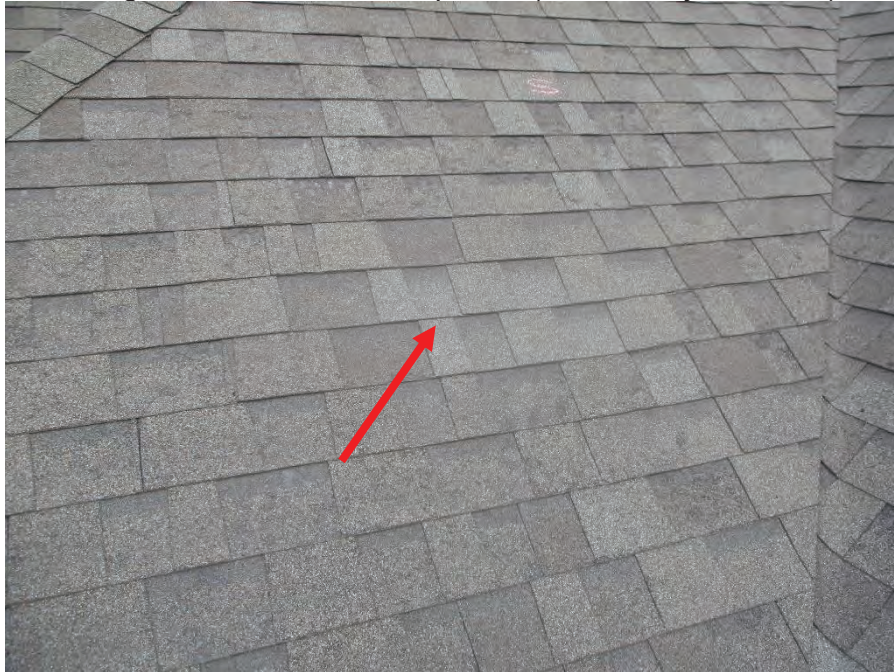
Photograph 41

View of widespread areas of granule loss on a south-facing roof slope of the residence. Note the absence of granule loss on the shingles in the center of the picture (indicated by the arrow).

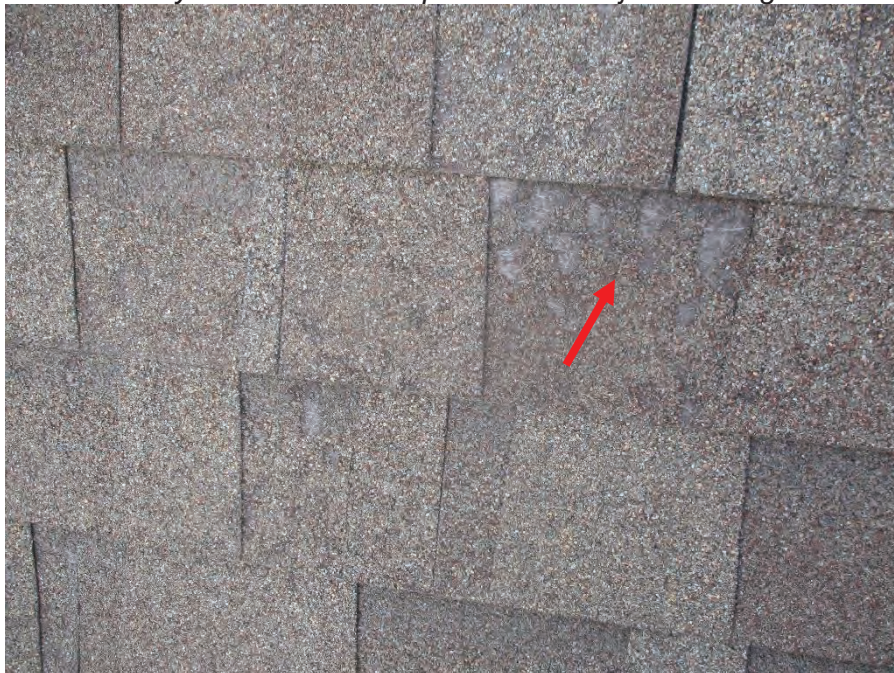
Photograph 42

Close-up view of an area of granule loss shown in Photograph 41. Note the frequency of areas of granule loss at the location indicated by the arrow as compared to the adjacent shingles.

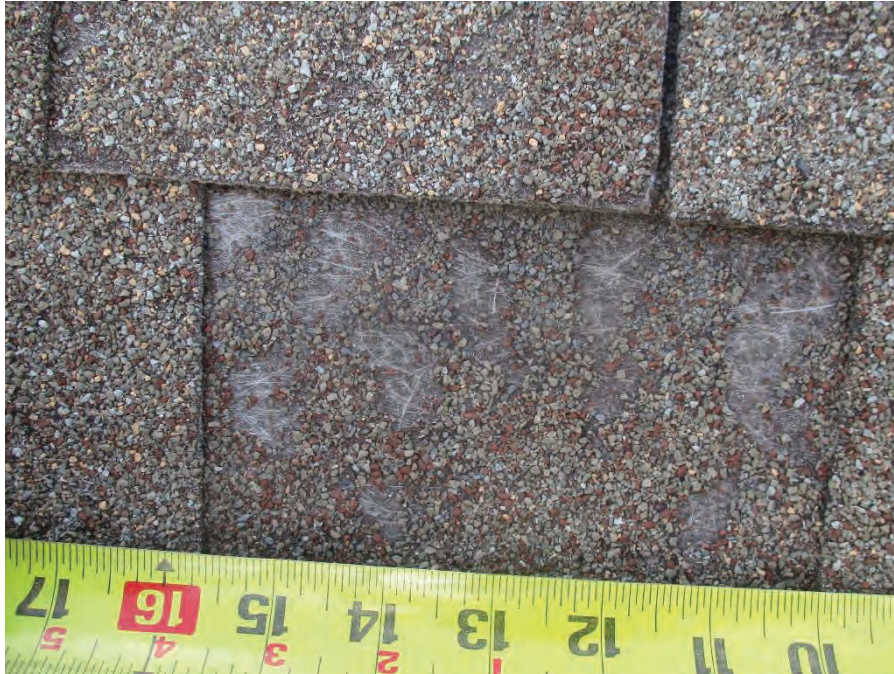
Photograph 43

Close-up view of the area indicated by the arrow in Photograph 42. Note the exposed fibers and light gray coloration of the shingle mat.
